FACTUAL NOTES, ENGINE TEARDOWN INVESTIGATION IN SUPPORT OF ACCIDENT INVESTIGATION OF BEECHCRAFT B-90 REG. N338AS PERFORMED FOR THE NATIONAL TRANSPORTATION SAFETY BOARD.

PT6A-20 S/N 20801

PT6A-20 S/N 22008

Report No.: TL-1503

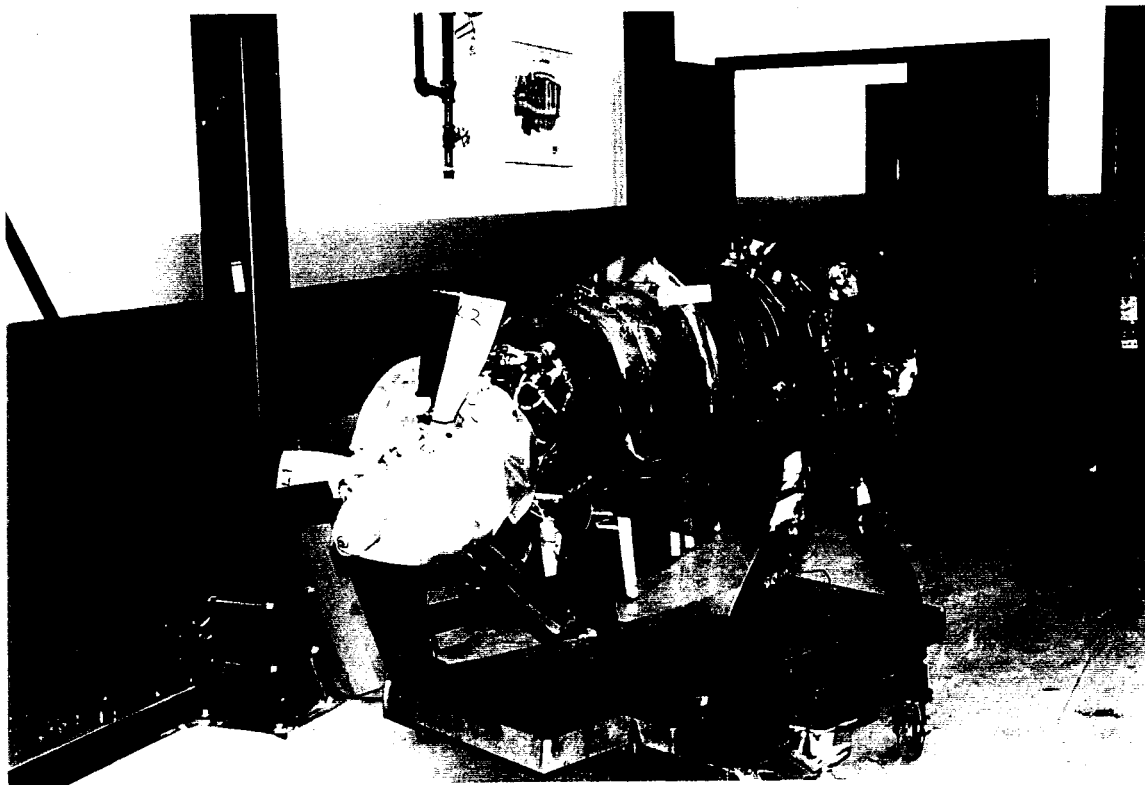
Photo No. 1
Engine left hand forward view.

The engine displayed moderate impact damage and light post impact fire damage. The engine was received with the airframe related propeller hub, exhaust stubs, starter generator, and pressurisation supercharger attached. The propeller was removed for inspection by the Hartzell Representative. Following external inspection, the engine related controls and accessories were removed for separate investigation. Please refer to section 3.3 of this report for details of this activity.

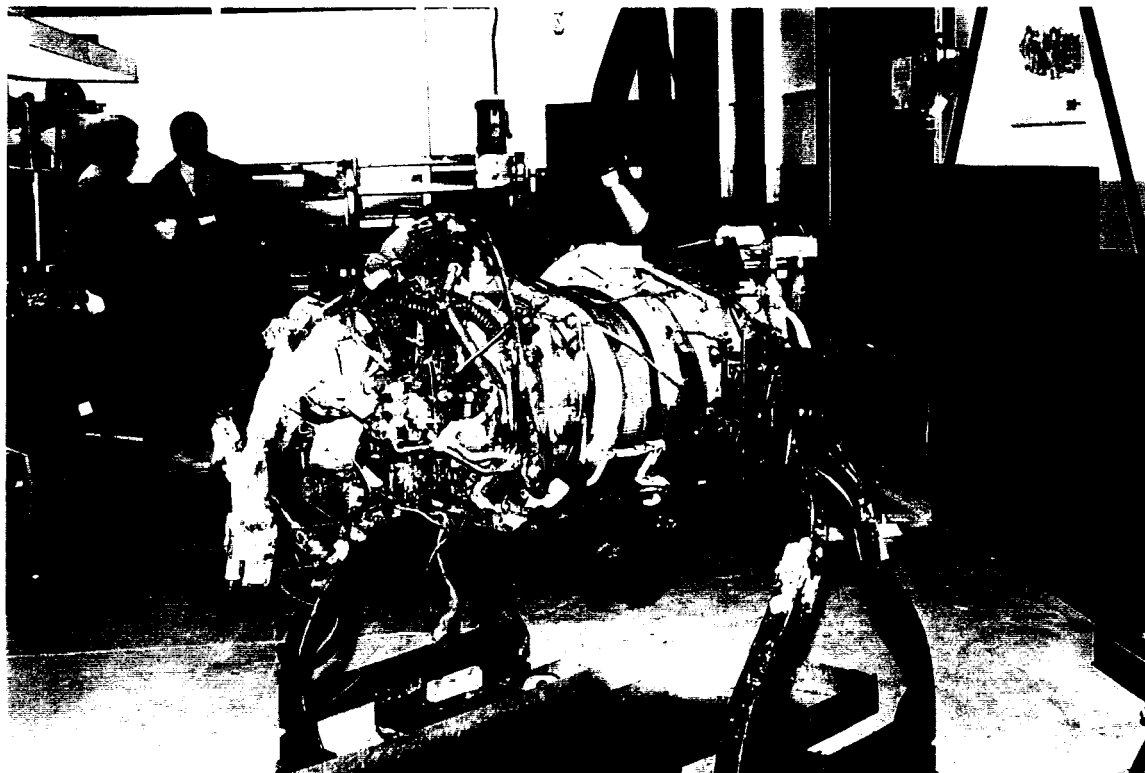
Photo No. 2
Engine right hand aft view.

Exhaust Duct: Displayed compressional deformation. The reduction gearbox was separated from the forward flange around the right hand circumference, and displaced approximately 20 degrees to the left in relation to the engine centreline.

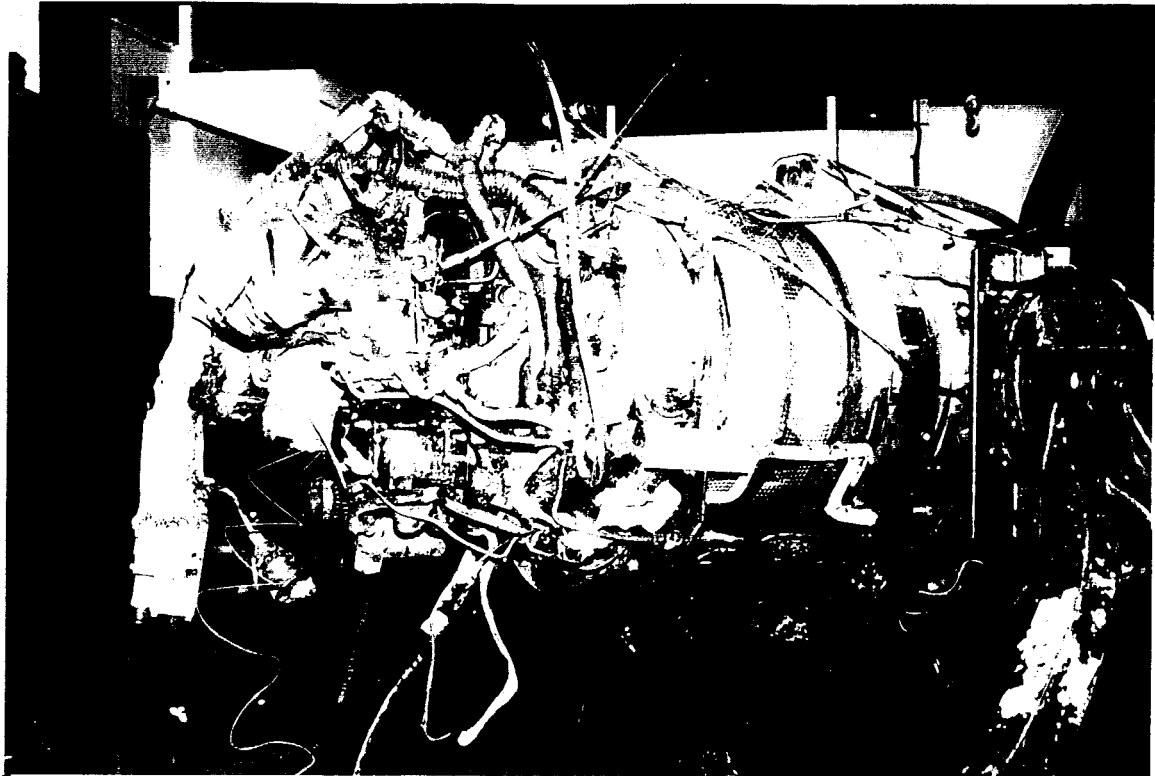
Photo No. 3

Accessory Gearbox: The housing was intact. The oil to fuel heater was fractured from it's mounting boss. The high pressure fuel pump and fuel control unit were in place and intact, with fire and heat damage. The T2 compensator was in place and intact.

Accessory gearbox and aft gas generator case, right hand aft view.

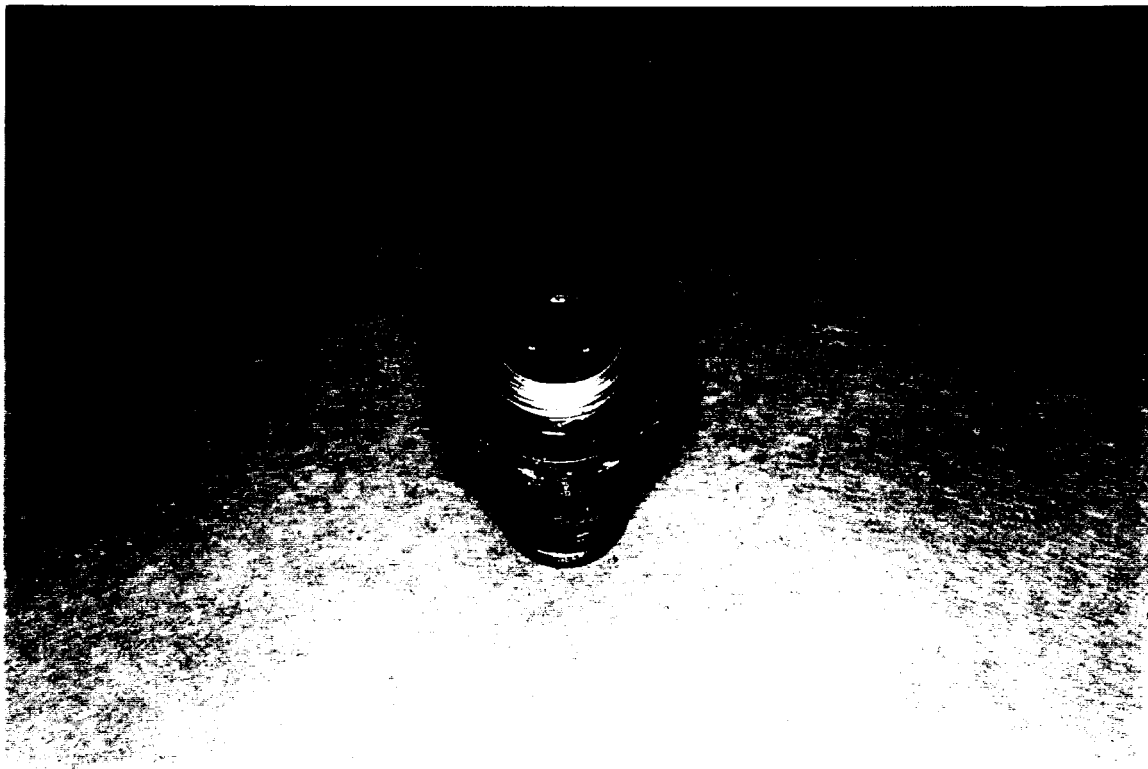
Photo No. 4

Reduction Gearbox Chip Detector: Clean.

Reduction gearbox chip detector.

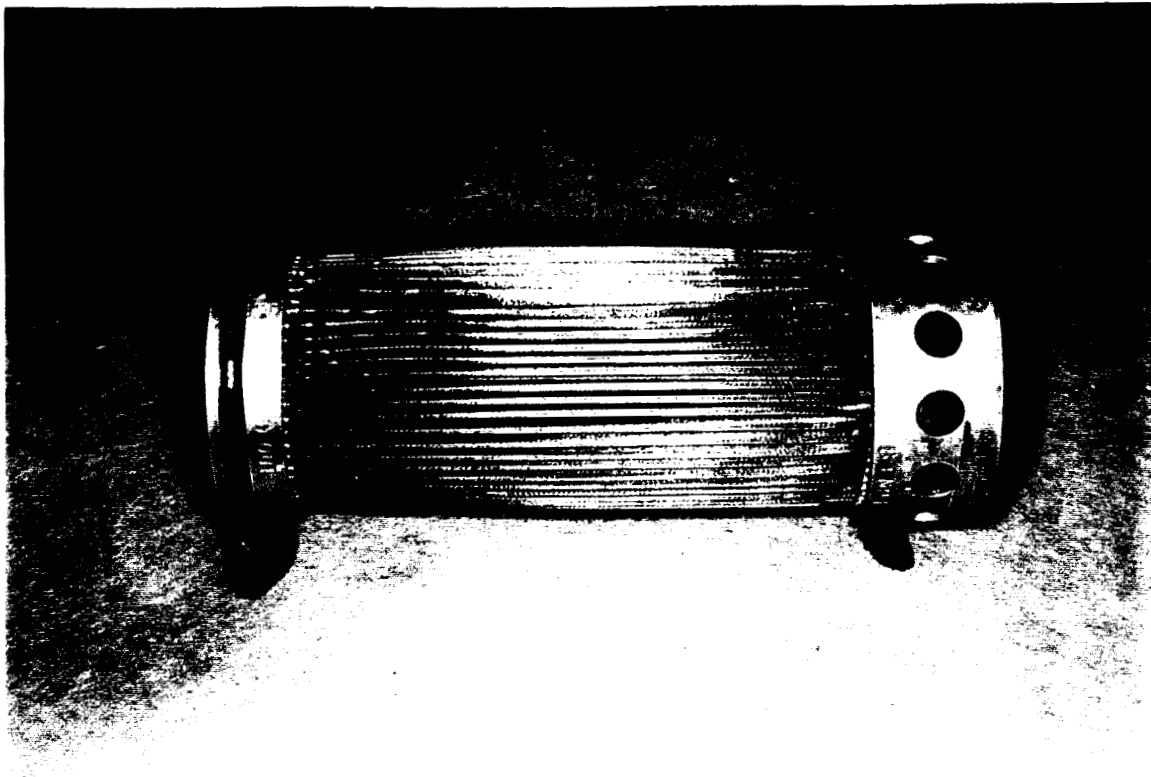
Photo No. 5
Oil filter.

Oil Filter: Clean.

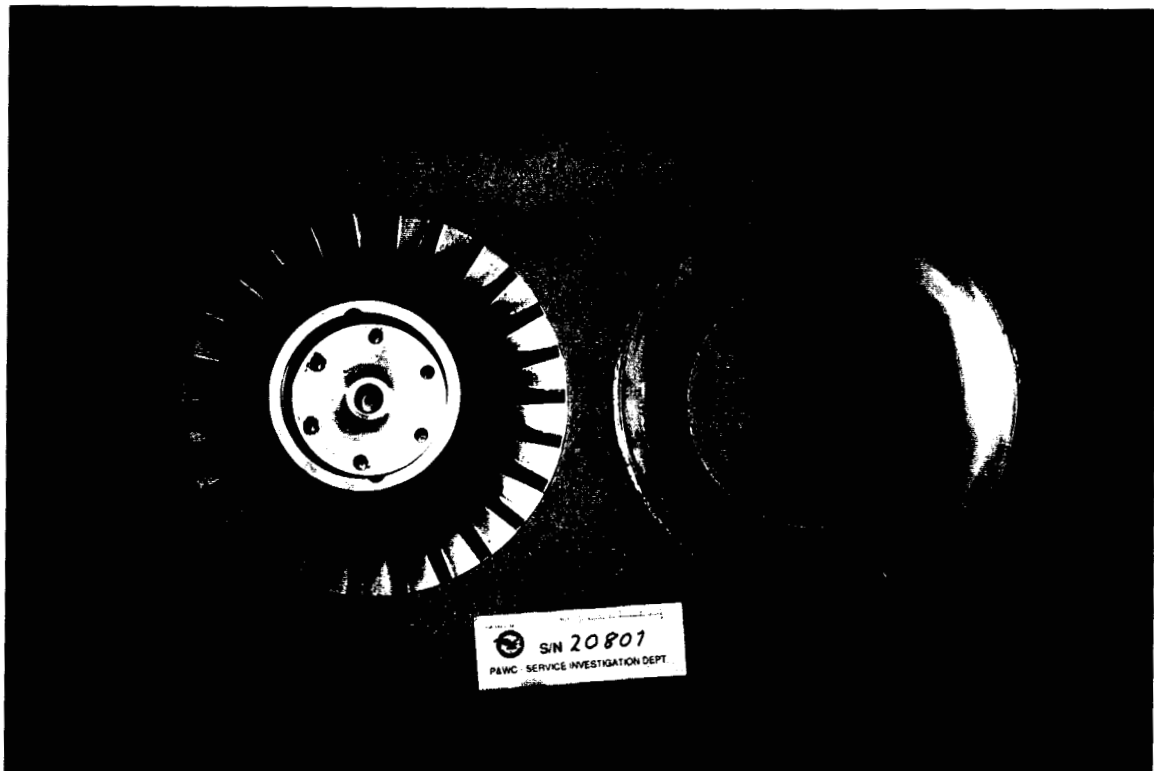
Photo No. 8
Centrifugal impeller and shroud.

Centrifugal Impeller: The impeller vane tips displayed light circumferential rubbing due to contact with the impeller shroud.

Centrifugal Impeller Shroud: The shroud face displayed light circumferential rubbing due to contact with the impeller.

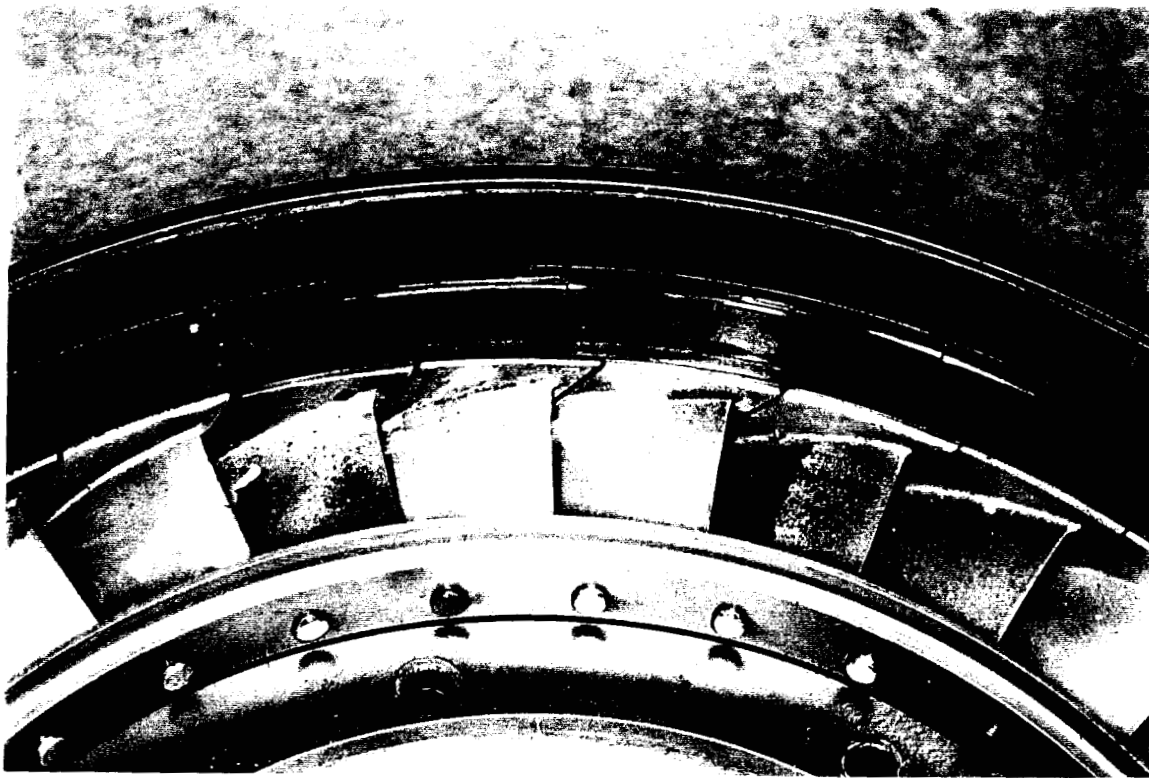
Photo No. 15

Compressor Turbine Shroud: Displayed light circumferential scoring due to radial contact with the compressor turbine blade tips.

Compressor turbine guide vane ring and compressor turbine shroud, detail.

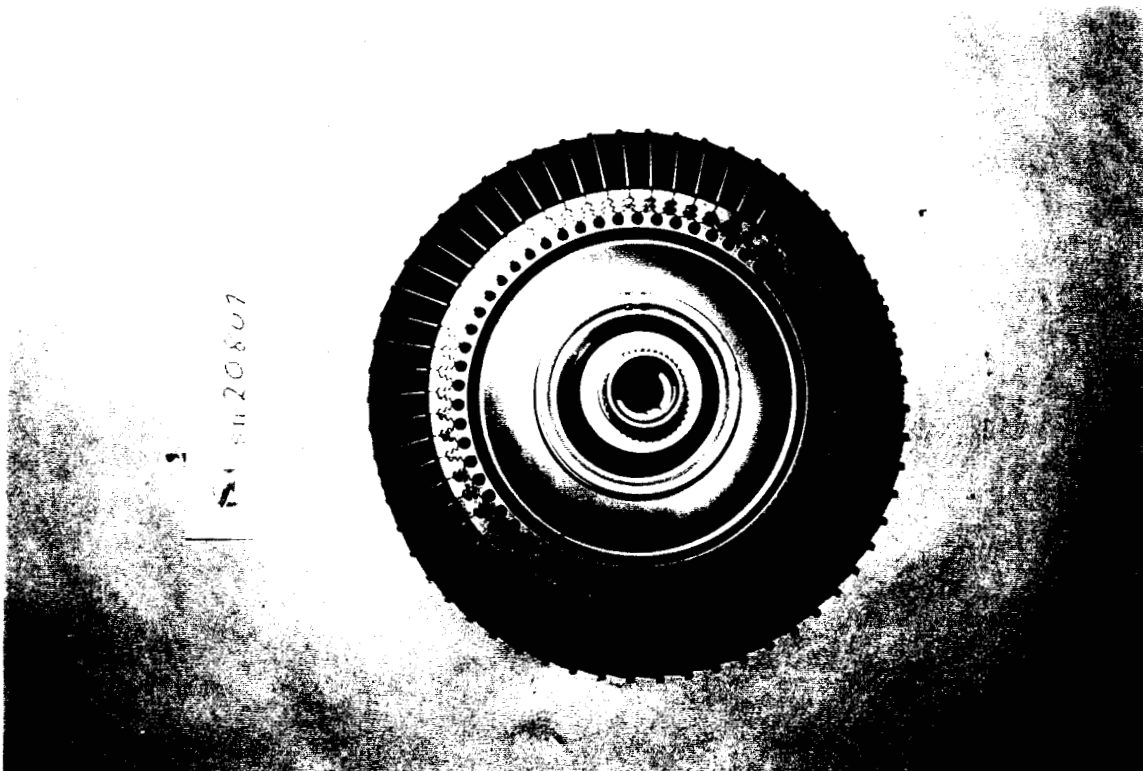
Photo No. 16

Compressor Turbine: The blade tips displayed light circumferential rubbing due to radial contact with the compressor turbine shroud. The downstream side disc face displayed light circumferential scoring due to axial contact with the interstage baffle.

Compressor turbine, upstream side.

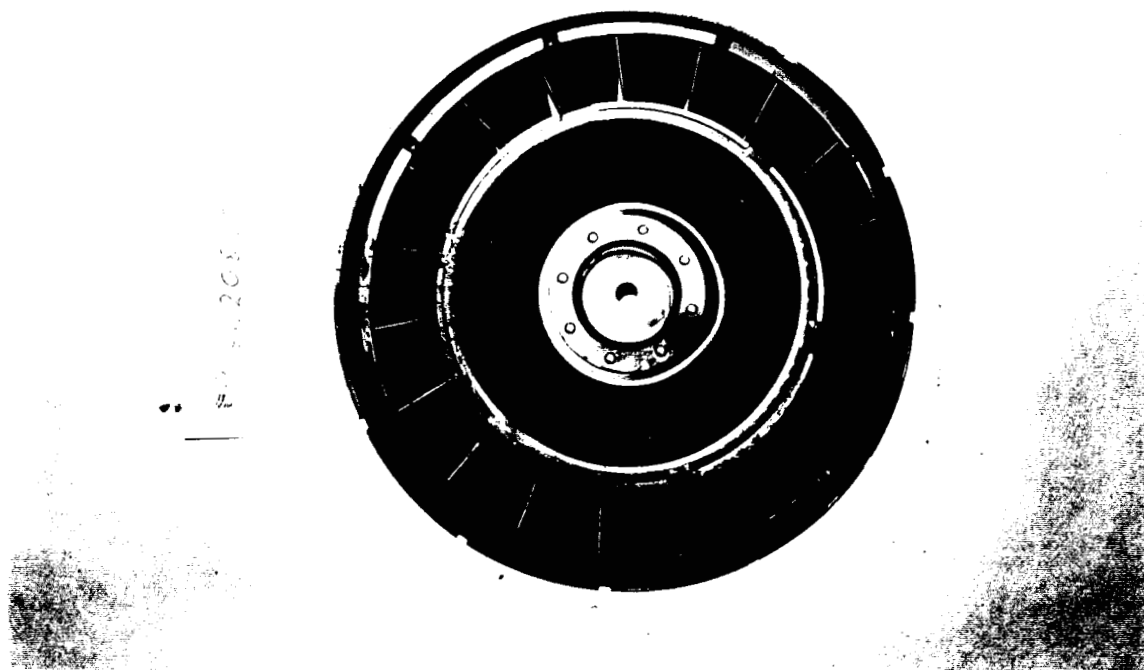
Photo No. 20
Power turbine guide vane ring and interstage baffle, upstream side.

Power Turbine Guide Vane Ring and Interstage Baffle: The vane airfoils displayed no indications of operational distress. The inner drum downstream side and interstage baffle outer rim displayed light circumferential rubbing due to axial contact with the compressor turbine disc. The baffle inner cup was circumferentially scored and radially deformed due to contact with the disc hub spigot. The inner drum downstream side was fractured and deformed from the approximate 2:00 to 4:00 positions due to axial contact with the power turbine. The downstream side outer drum was circumferentially scored due to axial contact with the power turbine blade tip shrouds. The inner drum and baffle outer rim displayed light circumferential rubbing, with light static imprint marks around the lower circumference, due to axial contact with the power turbine disc. The baffle inner cup was severely deformed due to contact with the power turbine hub spigot.

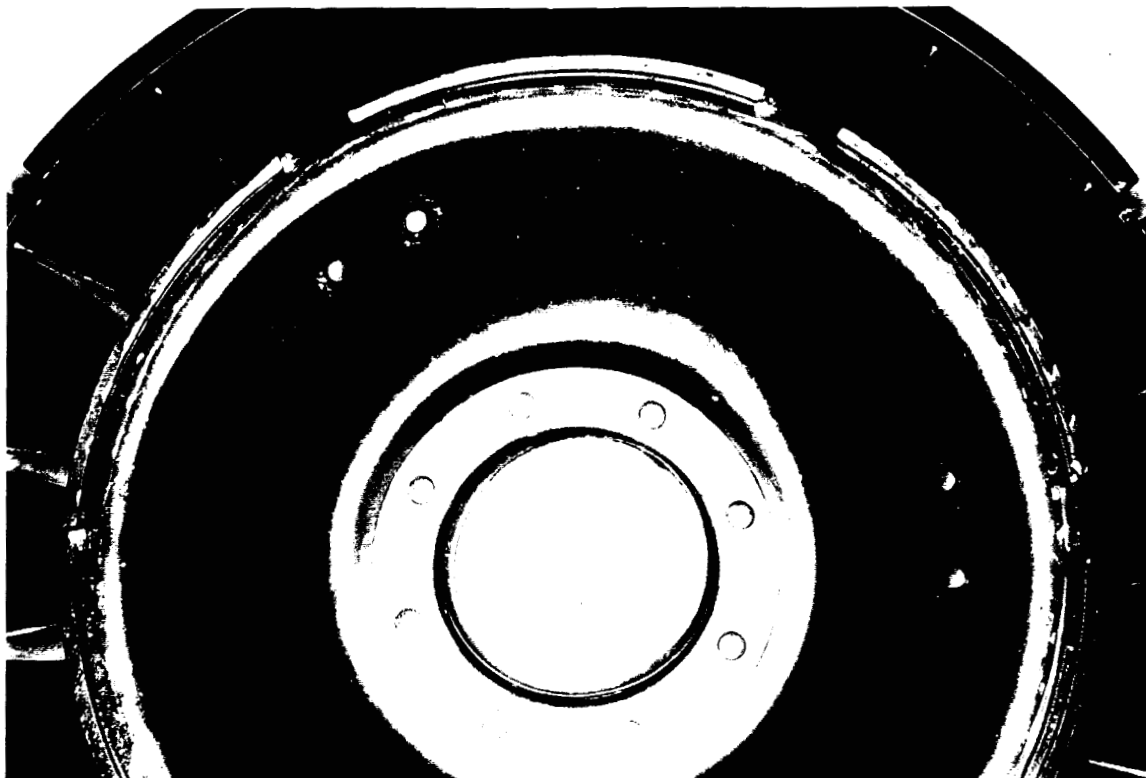
Photo No. 21

Power turbine guide vane ring and interstage baffle upstream side, detail.

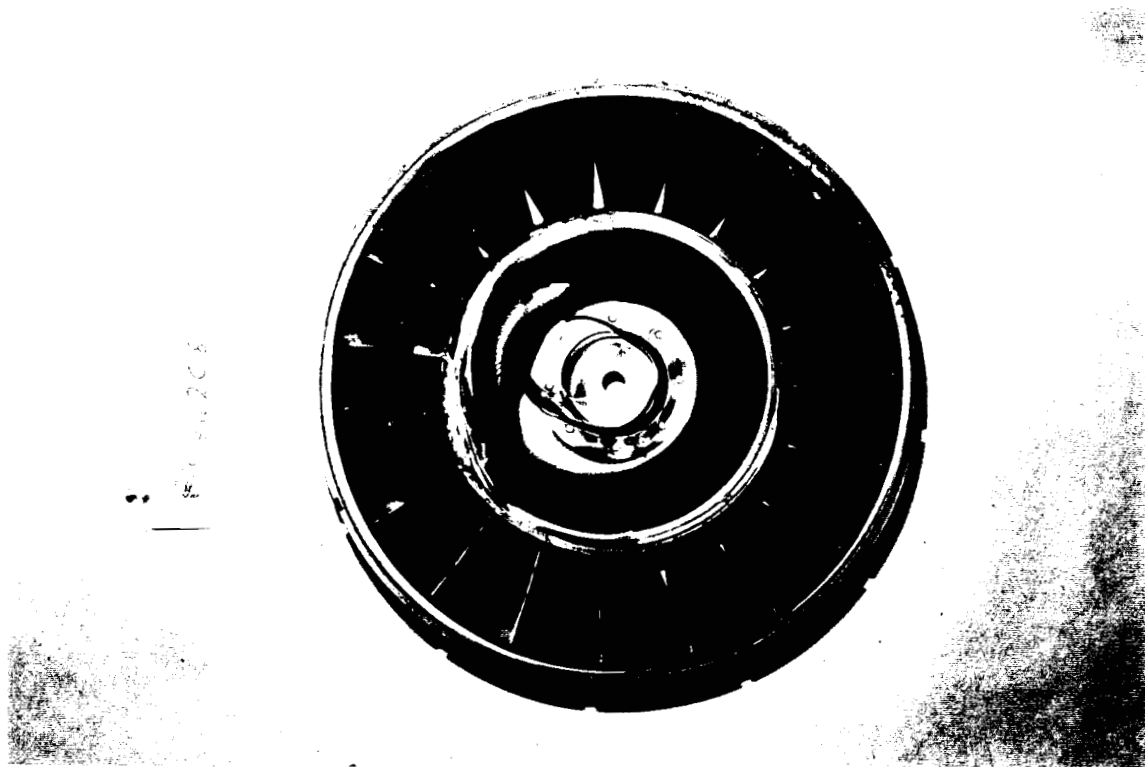
Photo No. 22

Power turbine guide vane ring and interstage baffle, downstream side.

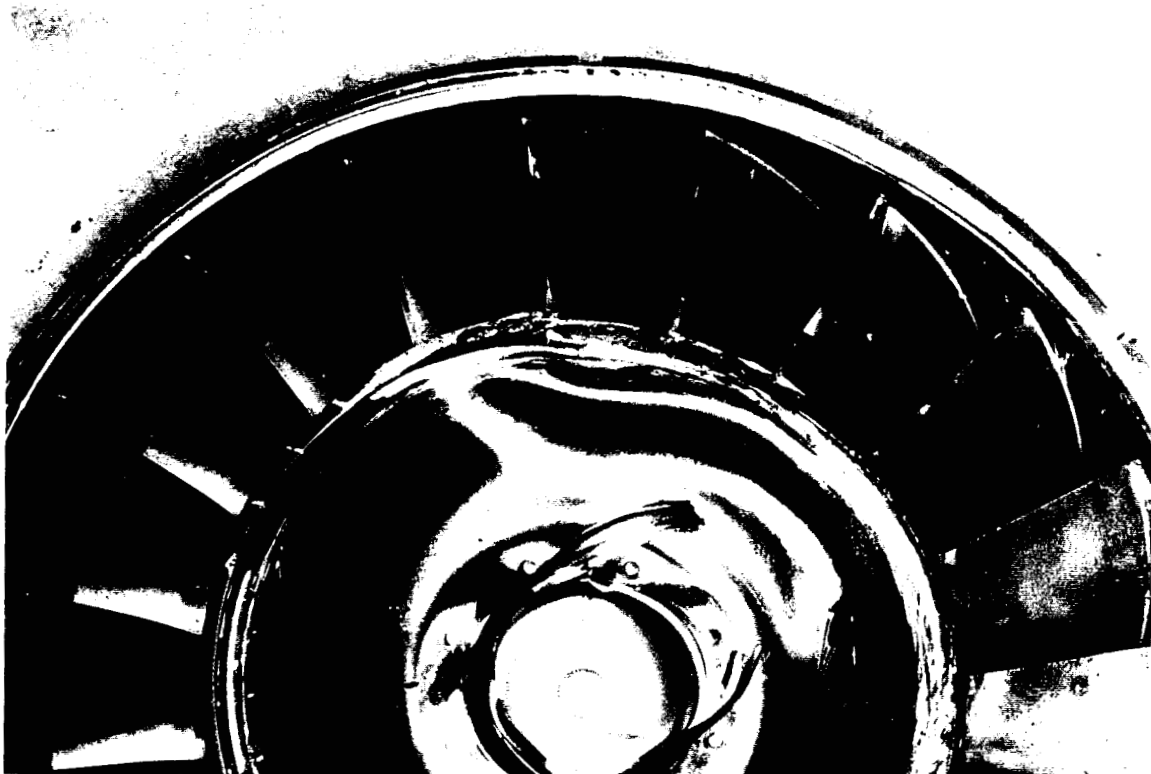
Photo No. 23

Power turbine guide vane ring and interstage baffle downstream side, detail.

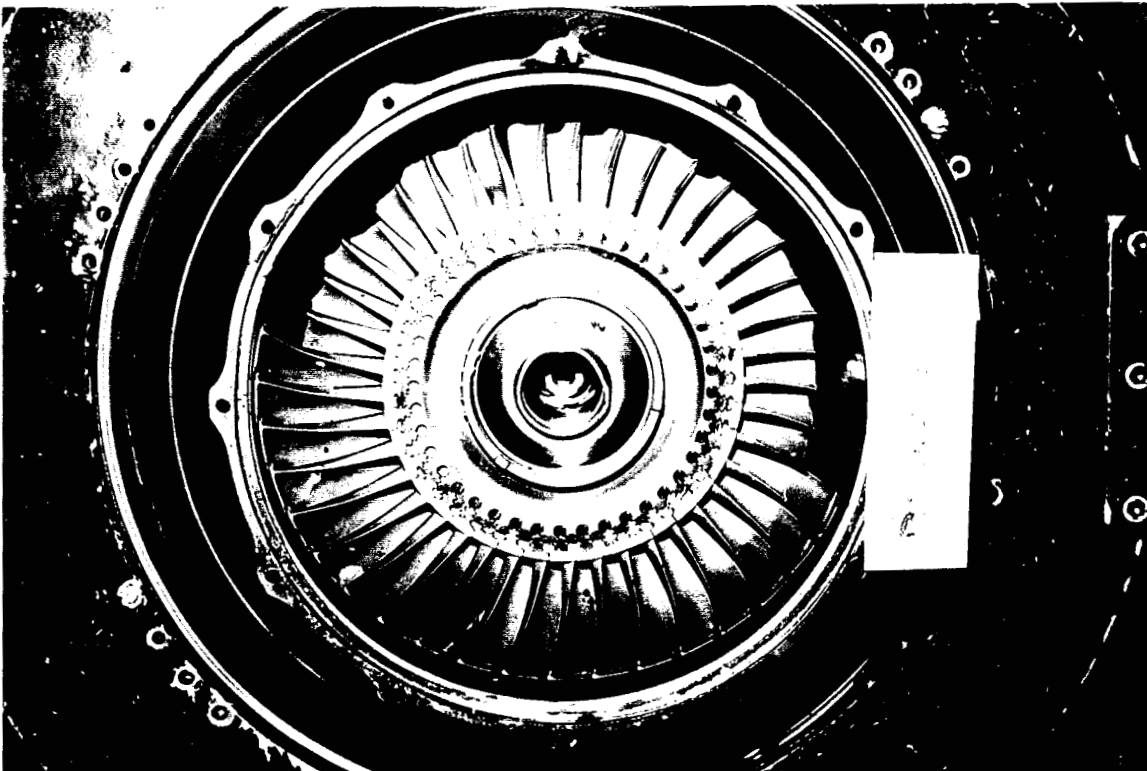
Photo No. 24

Power Turbine: Observed in-situ. The vane airfoils across approximately $\frac{1}{2}$ of the disc diameter were deformed into the direction of rotation and fractured at approximately $\frac{2}{3}$ span, due to axial and radial contact with the power turbine shroud and guide vane ring. The vane tips were circumferentially rubbed due to radial contact with the power turbine shroud. The power turbine disc displayed no distress.

Power turbine upstream side, in-situ.

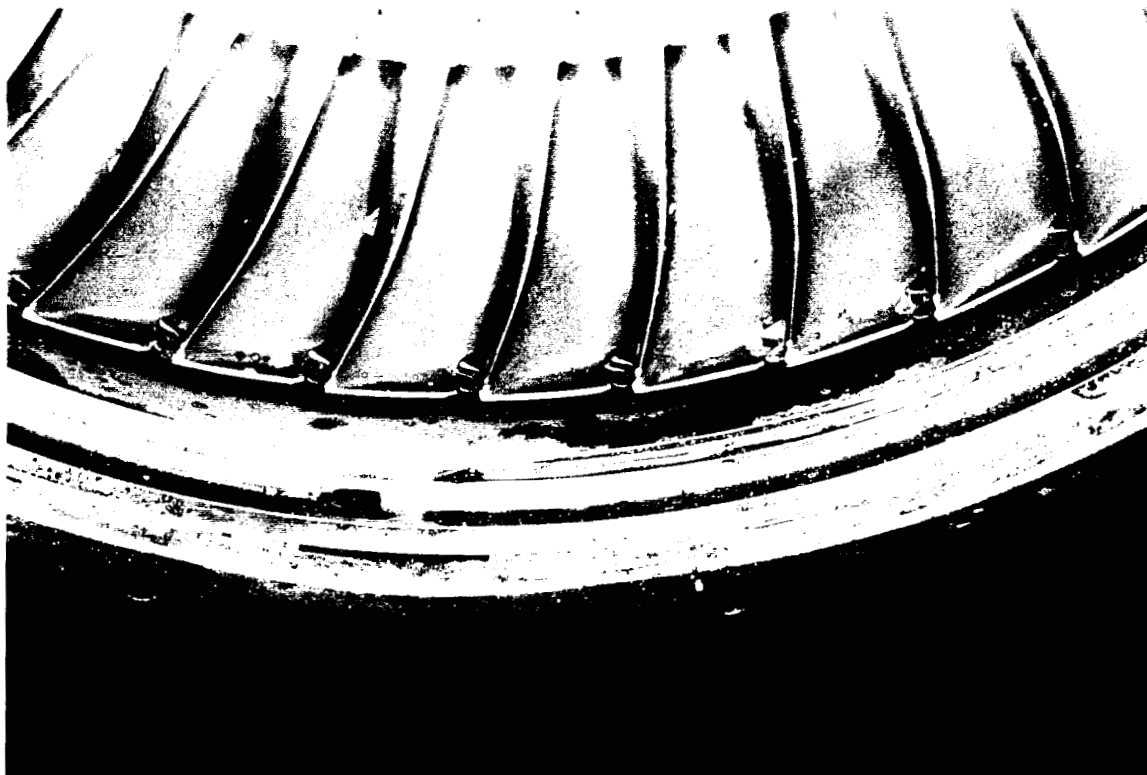
Photo No. 25

Power Turbine Shroud: Displayed circumferential rubbing due to radial contact with the power turbine blade tips.

Power turbine shroud and blade tips, in-situ, detail.

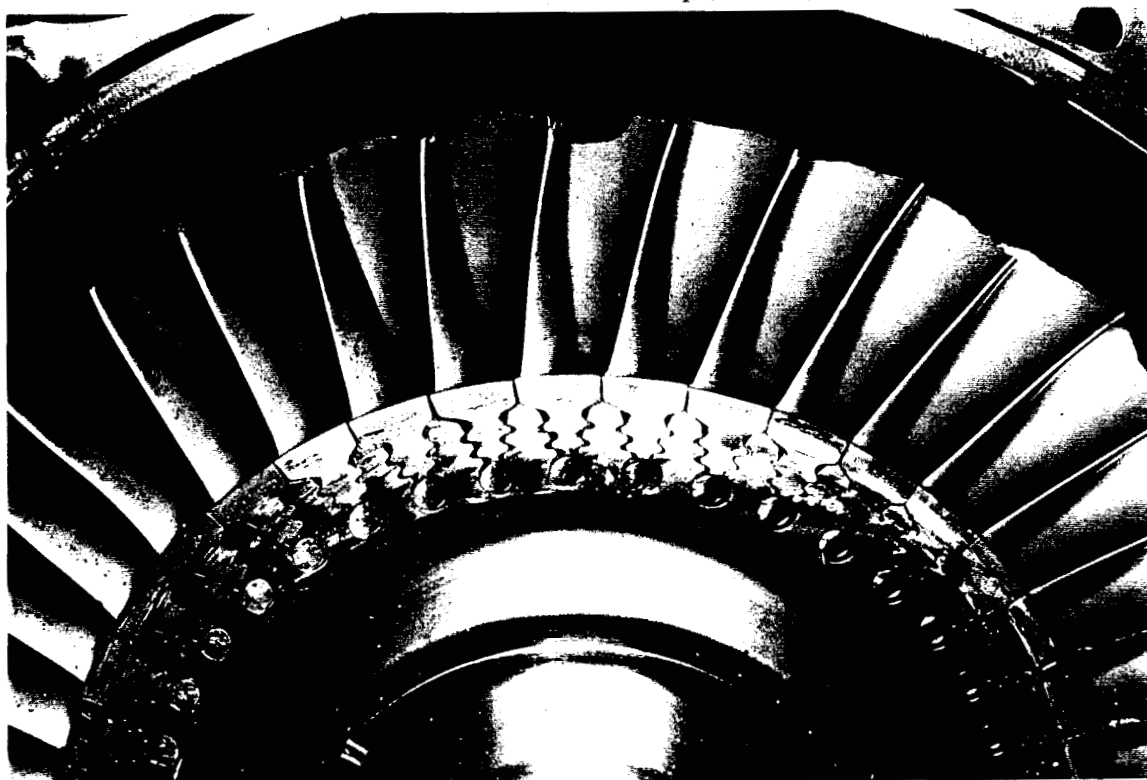
Photo No. 26

Power turbine upstream side, detail.

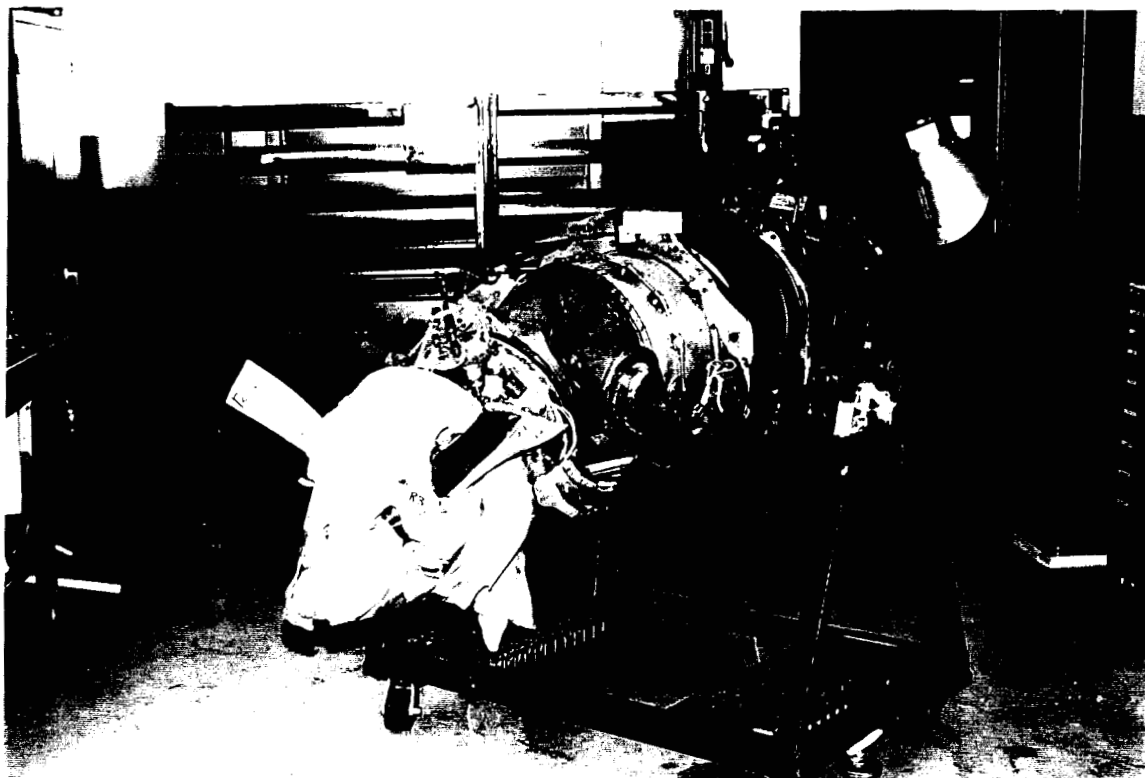
Photo No. 29
Engine left hand forward view.

The engine displayed moderate impact damage and light post impact fire damage. The engine was received with the airframe related propeller hub, exhaust stubs, and starter generator attached. The propeller was removed for inspection by the Hartzell Representative. Following external inspection, the engine related controls and accessories were removed for separate investigation. Please refer to section 5.3 of this report for details of this activity.

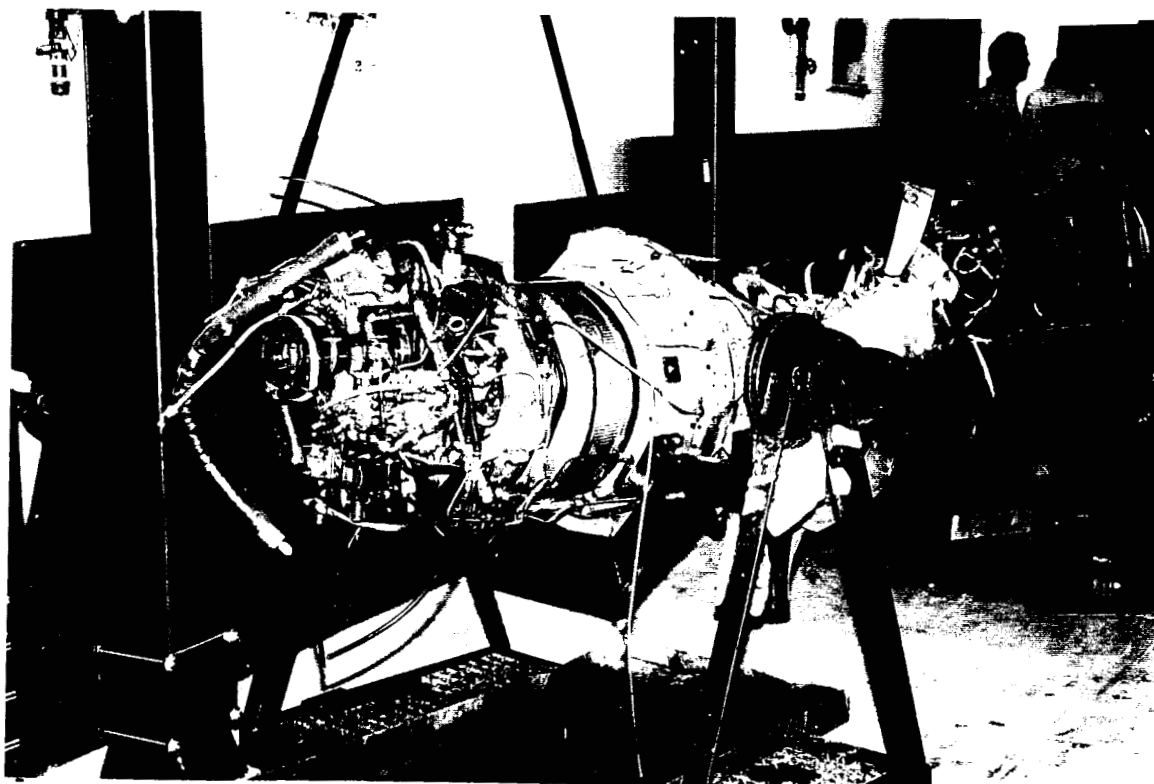
Photo No. 30
Engine right hand aft view.

Exhaust Duct: Displayed compressional damage around the lower circumference. The reduction gearbox was separated from the forward flange around the upper circumference, and displaced approximately 15 degrees downward in relation to the engine centreline.

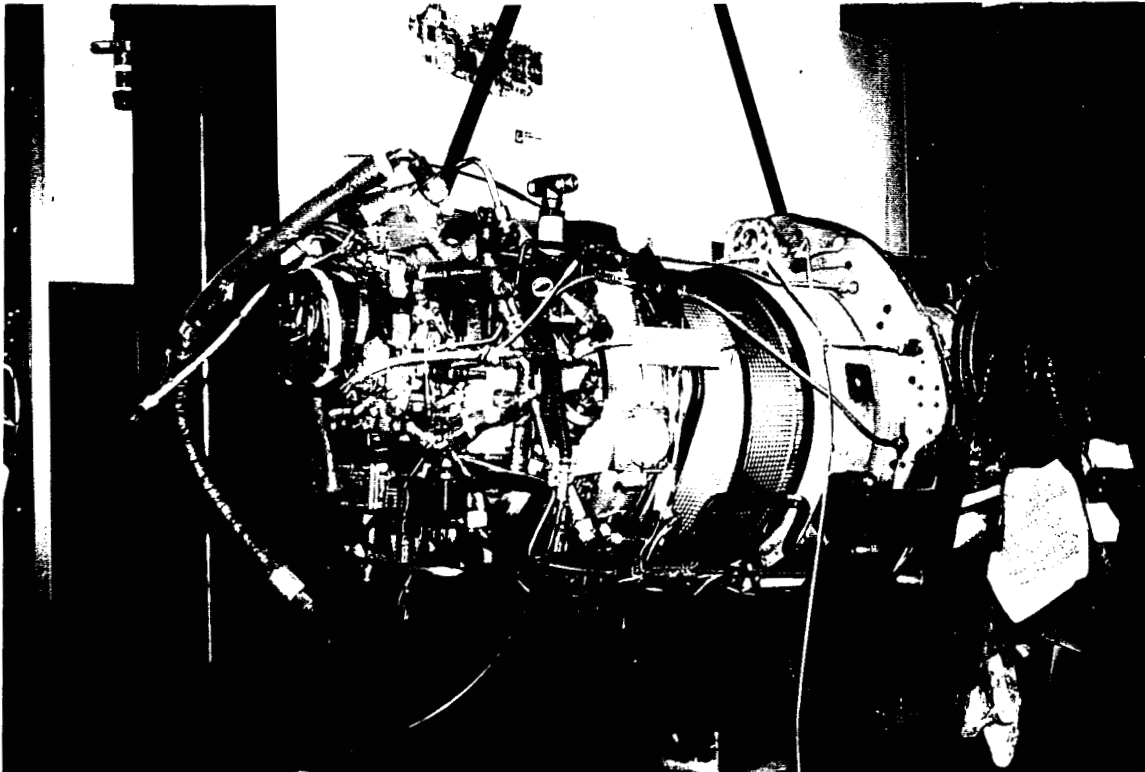
Photo No. 31

Accessory Gearbox: The housing was intact. The oil to fuel heater was fractured from it's mounting boss. The high pressure fuel pump and the fuel control unit were in place, with impact damage to the fuel control unit housing. The fuel control unit fuel output fitting was impact fractured. The T2 compensator was in place and intact.

Accessory gearbox and aft gas generator case, right hand aft view.

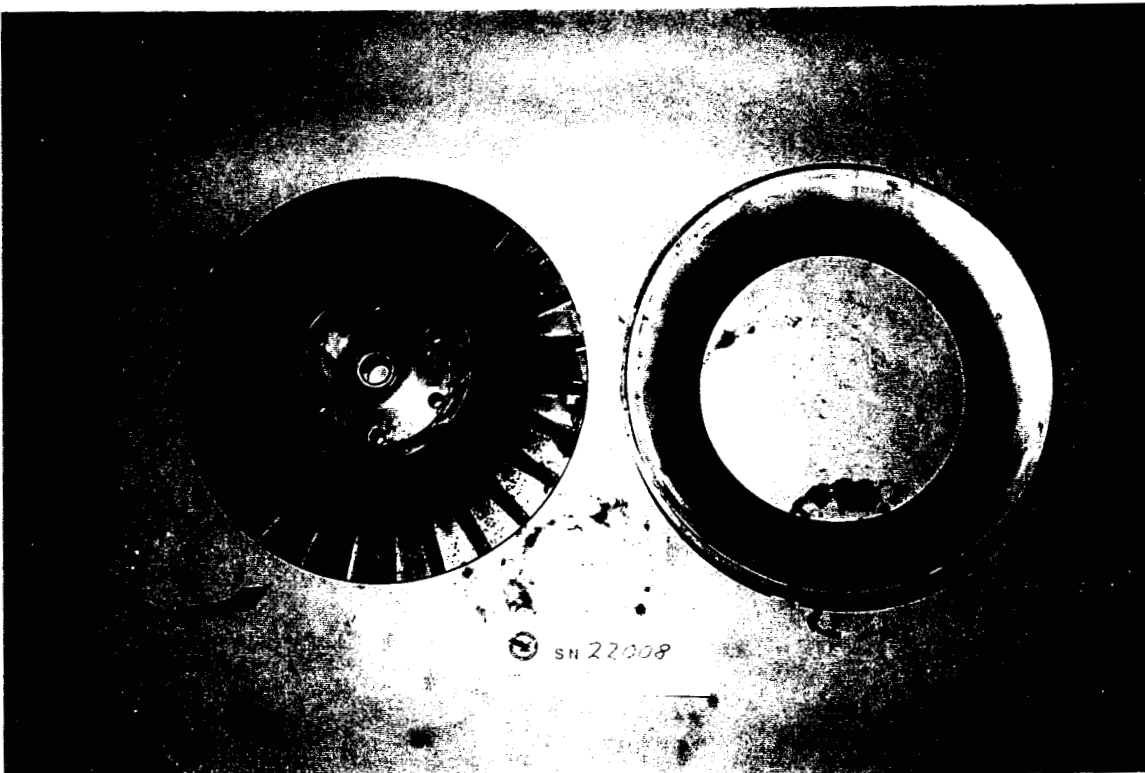
Photo No. 36
Centrifugal impeller and shroud.

Centrifugal Impeller: The impeller vane tips displayed light circumferential rubbing due to contact with the impeller shroud.

Centrifugal Impeller Shroud: The shroud face displayed light circumferential rubbing due to contact with the impeller.

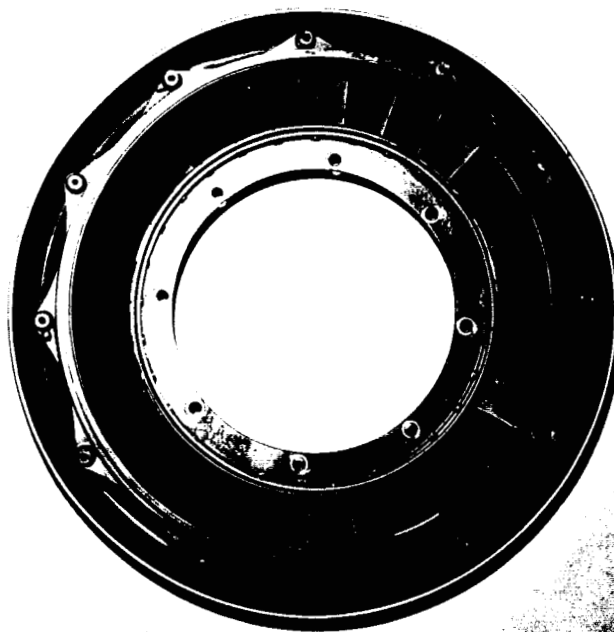
Photo No. 42

Compressor Turbine Guide Vane Ring: The vane airfoils displayed no indications of operational distress. Two of the airfoil leading edges displayed light burning and erosion.

Compressor turbine guide vane ring, downstream side.

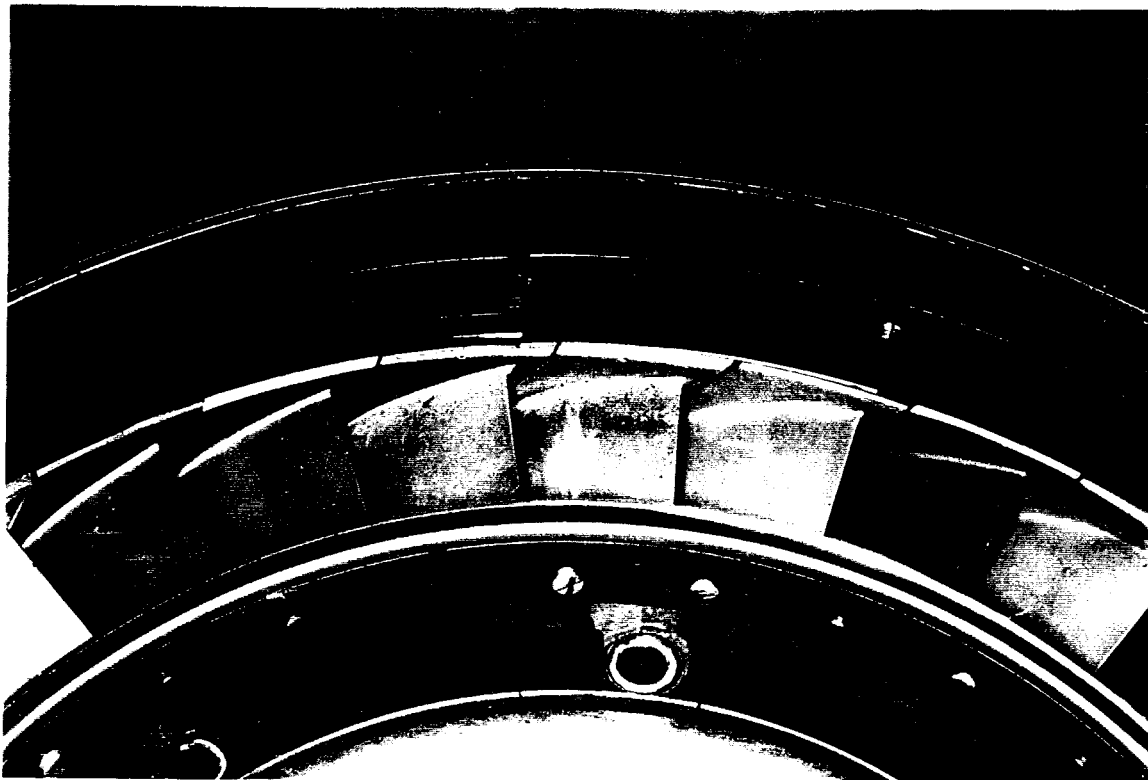
Photo No. 43

Compressor Turbine Shroud: Displayed light circumferential scoring due to radial contact with the compressor turbine blade tips.

Compressor turbine guide vane ring and compressor turbine shroud, detail.

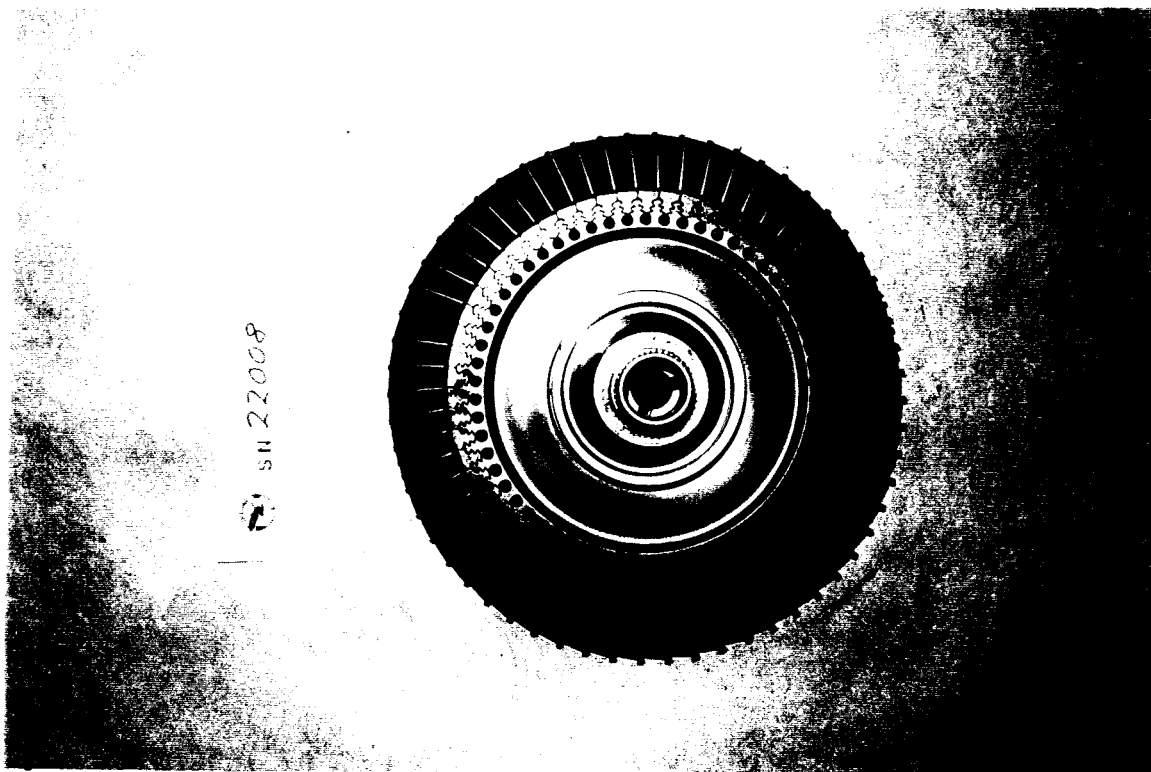
Photo No. 44

Compressor Turbine: The blade tips displayed light circumferential rubbing due to radial contact with the compressor turbine shroud. The downstream side disc face displayed light circumferential scoring due to axial contact with the interstage baffle.

Compressor turbine, upstream side.

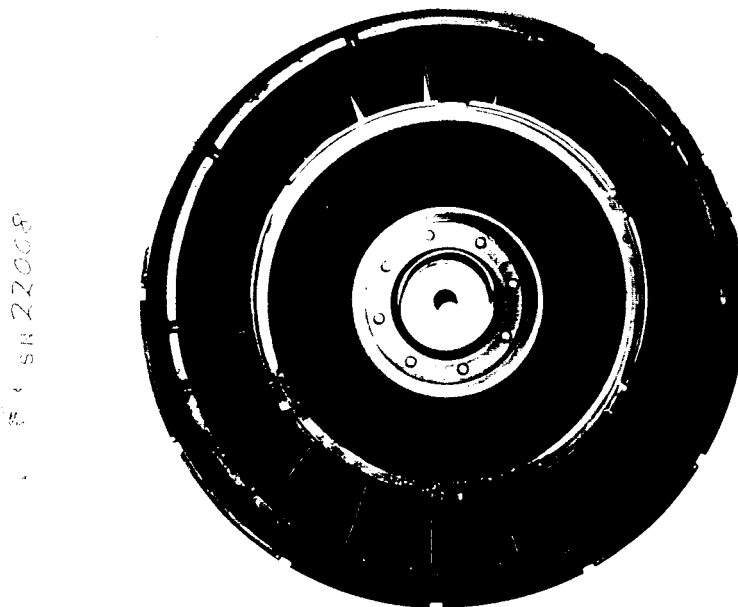
Photo No. 48
Power turbine guide vane ring and interstage baffle, upstream side.

Power Turbine Guide Vane Ring and Interstage Baffle: The vane airfoils displayed no indications of operational distress. The inner drum downstream side and interstage baffle outer rim were lightly circumferentially rubbed due to axial contact with the compressor turbine disc. The baffle inner cup was circumferentially scored and radially deformed due to contact with the disc hub spigot. The downstream side outer drum displayed light circumferential scoring, with concurrent static imprint marks, due to axial contact with the power turbine blade tip shrouds. The inner drum and baffle outer rim displayed light circumferential rubbing, with heavy static imprint marks and tearing of the baffle outer rim around the upper circumference, due to axial contact with the power turbine disc. The baffle inner cup was deformed due to contact with the power turbine hub spigot.

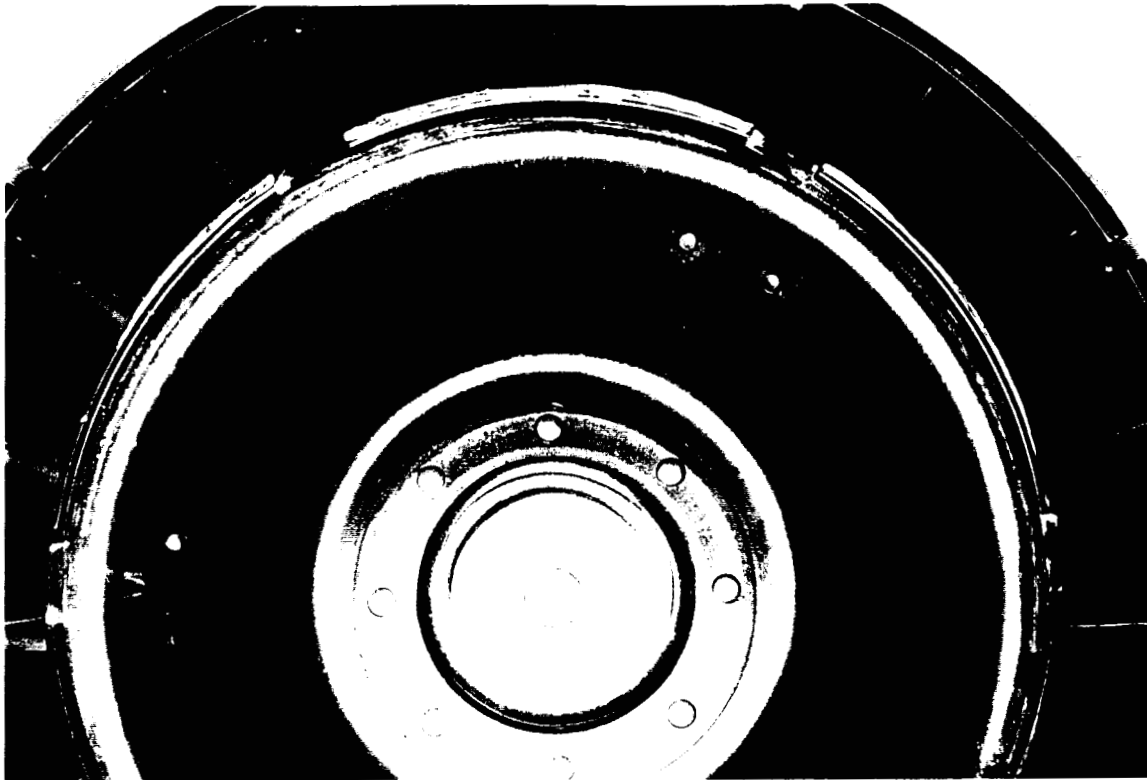
Photo No. 49

Power turbine guide vane ring and interstage baffle upstream side, detail.
